**RADIOLOGICAL CHARACTERIZATION REPORT FOR
FUSRAP PROPERTIES IN THE ST. LOUIS, MISSOURI, AREA**

VOLUME I

MARCH 1990

**K. C. Noey
C. M. Sekula
Bechtel National, Inc.
Oak Ridge, Tennessee**

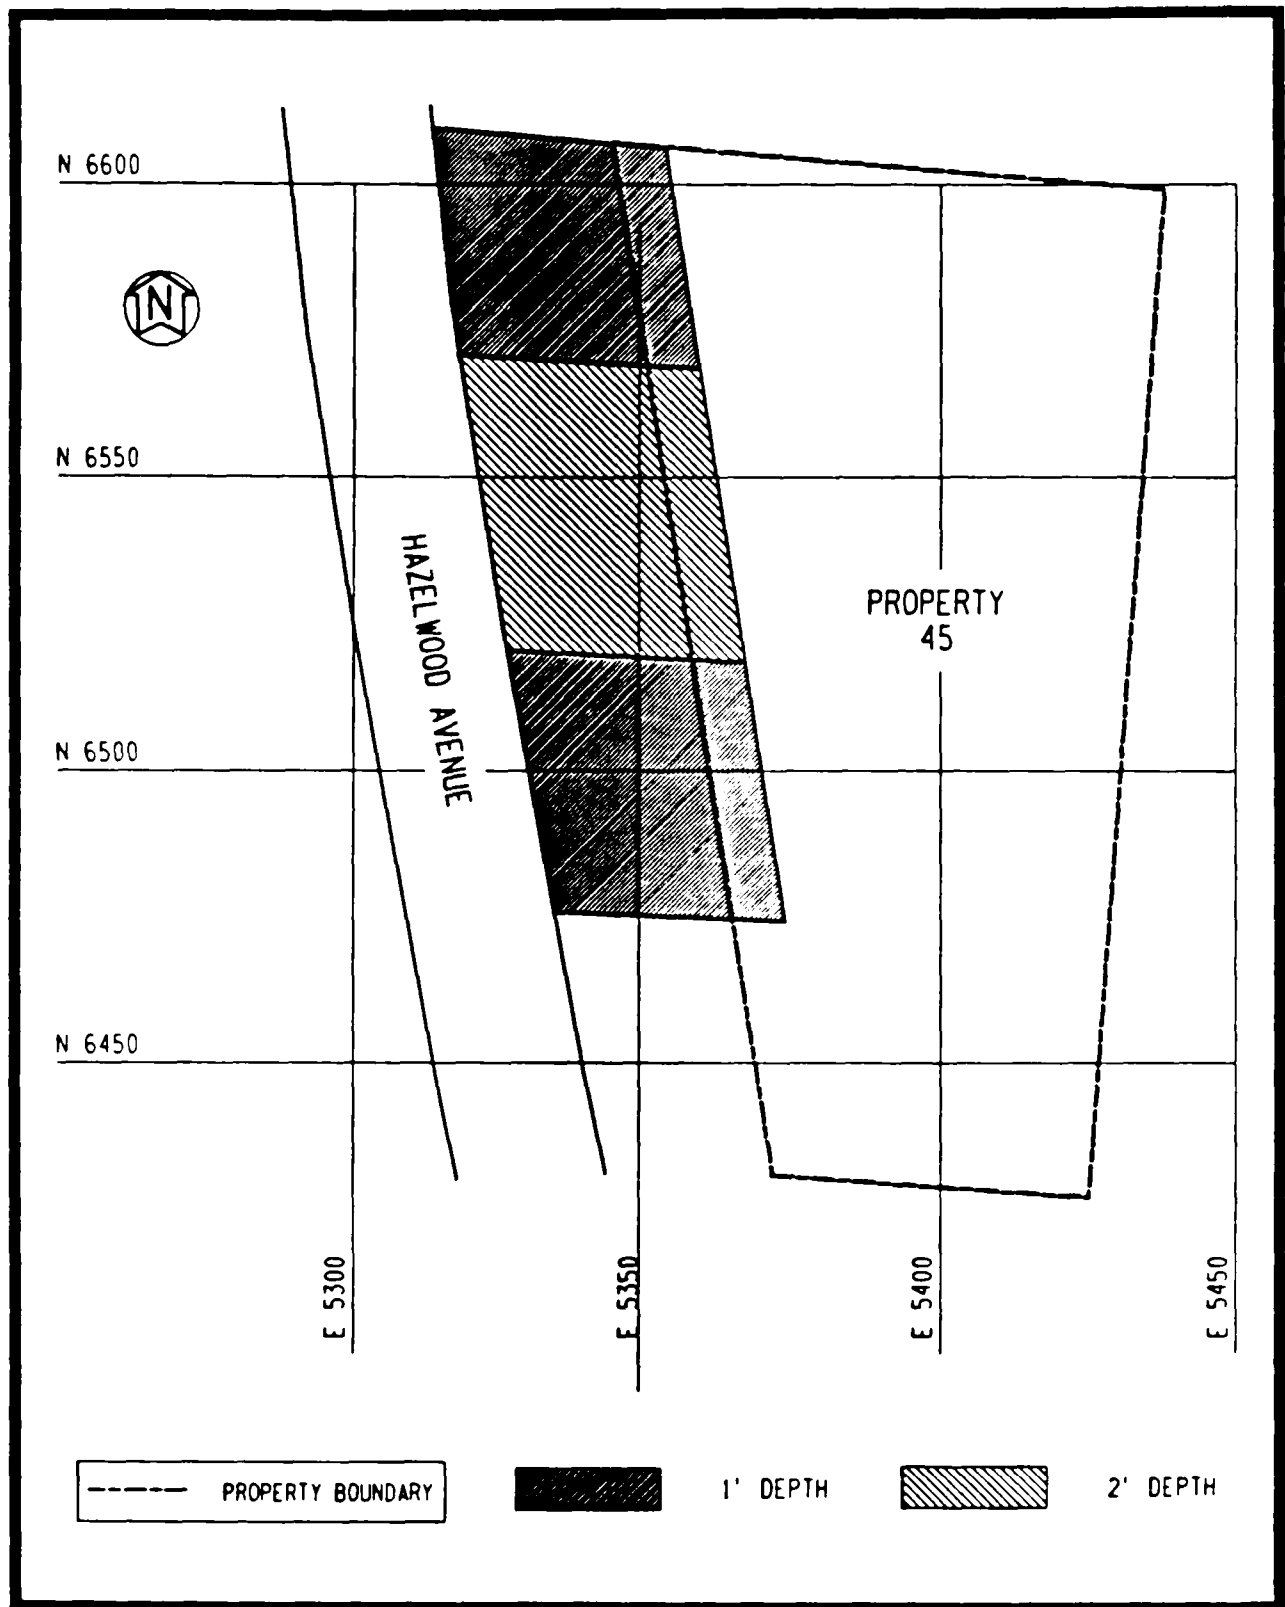
FIGURE 5-98 AREAS AND DEPTHS OF RADIOACTIVE CONTAMINATION
AT HAUL ROADS' VICINITY PROPERTY 45

Property 45 is located on Hazelwood Avenue. Locations from which soil samples were collected and analyzed are shown in Figure 5-97. Analytical results for soil (Table 5-61) revealed three sampling locations exhibiting elevated levels of thorium-230, which ranged from 1 to 21 pCi/g. Areas and depths of radioactive contamination at Property 45 are shown in Figure 5-98.

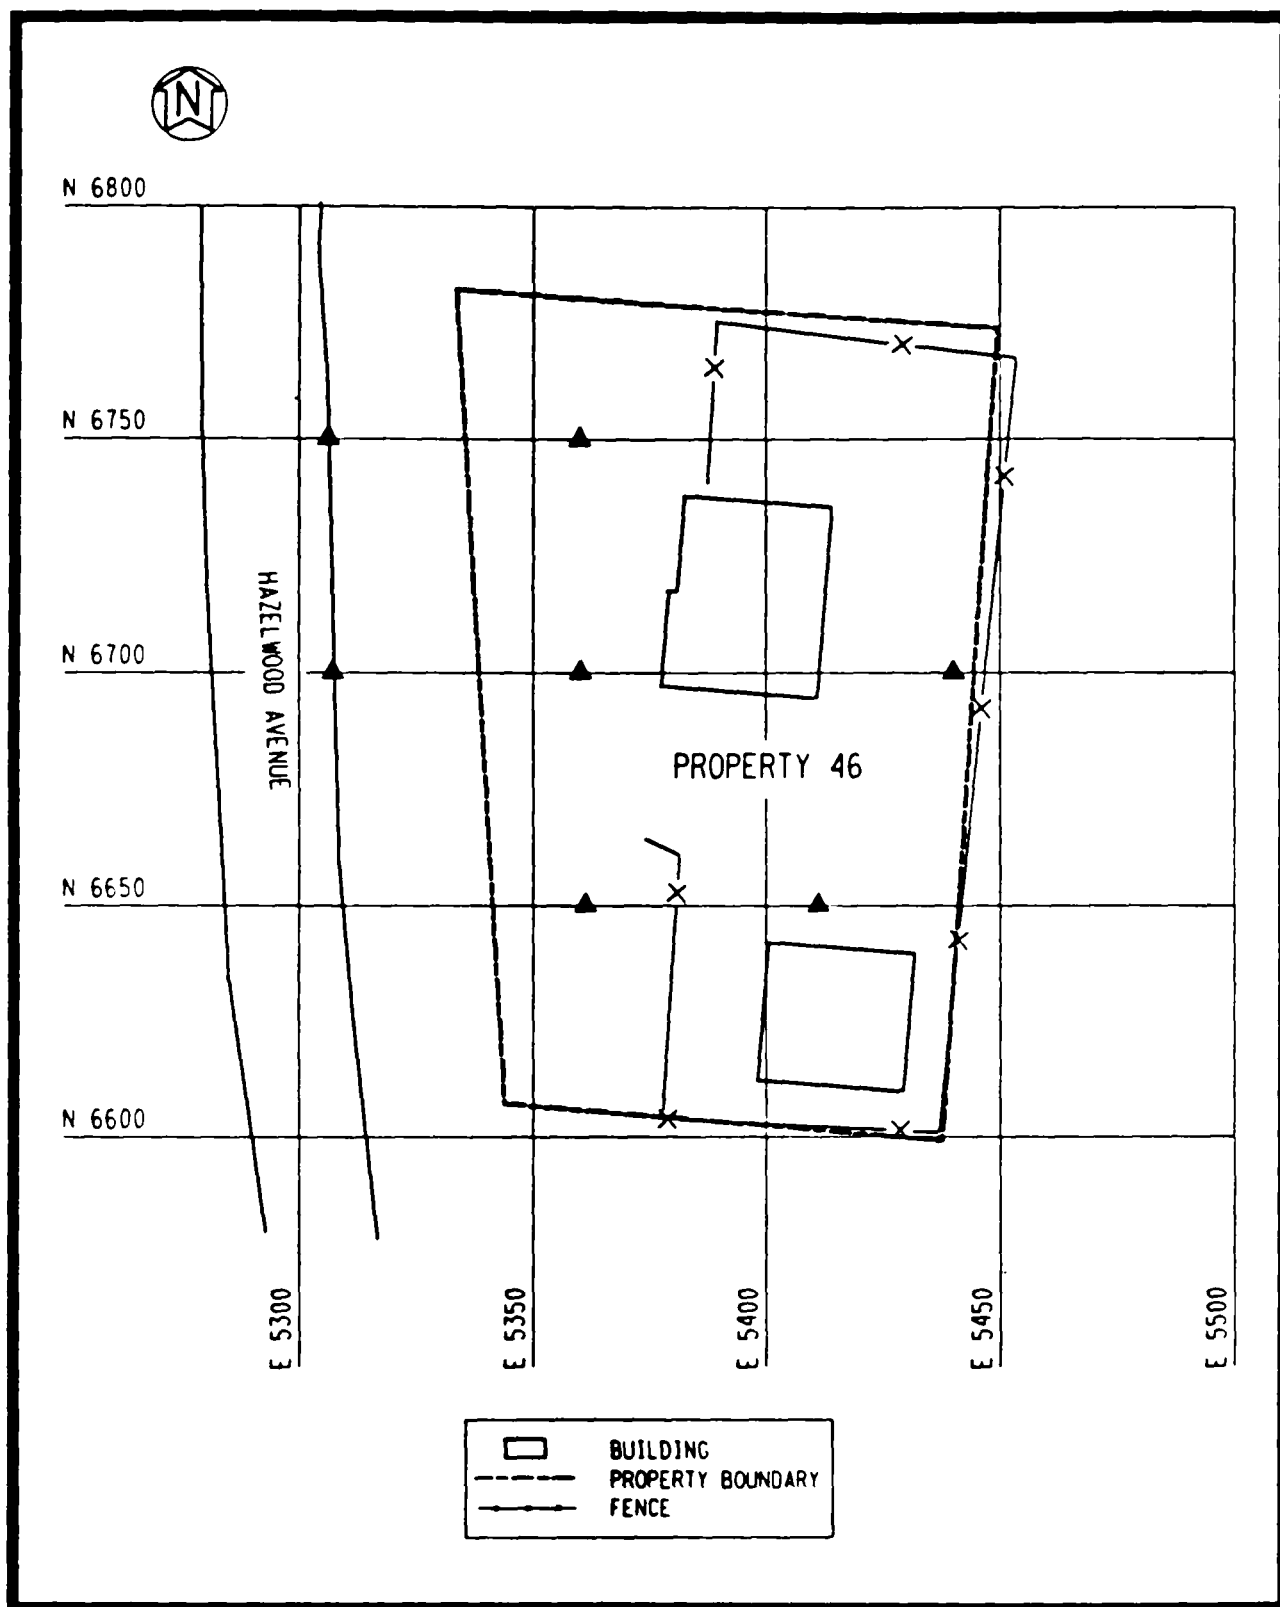
FIGURE 5-99 SOIL SAMPLING LOCATIONS FOR RADIOLOGICAL CHARACTERIZATION OF HAUL ROADS VICINITY PROPERTY 46

Property 46 is located on Hazelwood Avenue. Locations from which soil samples were collected and analyzed are shown in Figure 5-99. Analytical results for soil (Table 5-62) revealed one area with an elevated concentration of thorium-230. Thorium-230 concentrations ranged from less than 0.8 to 7 pCi/g. Additional soil sampling is required to better define the boundaries of radioactive contamination; this sampling will occur before remedial action begins.

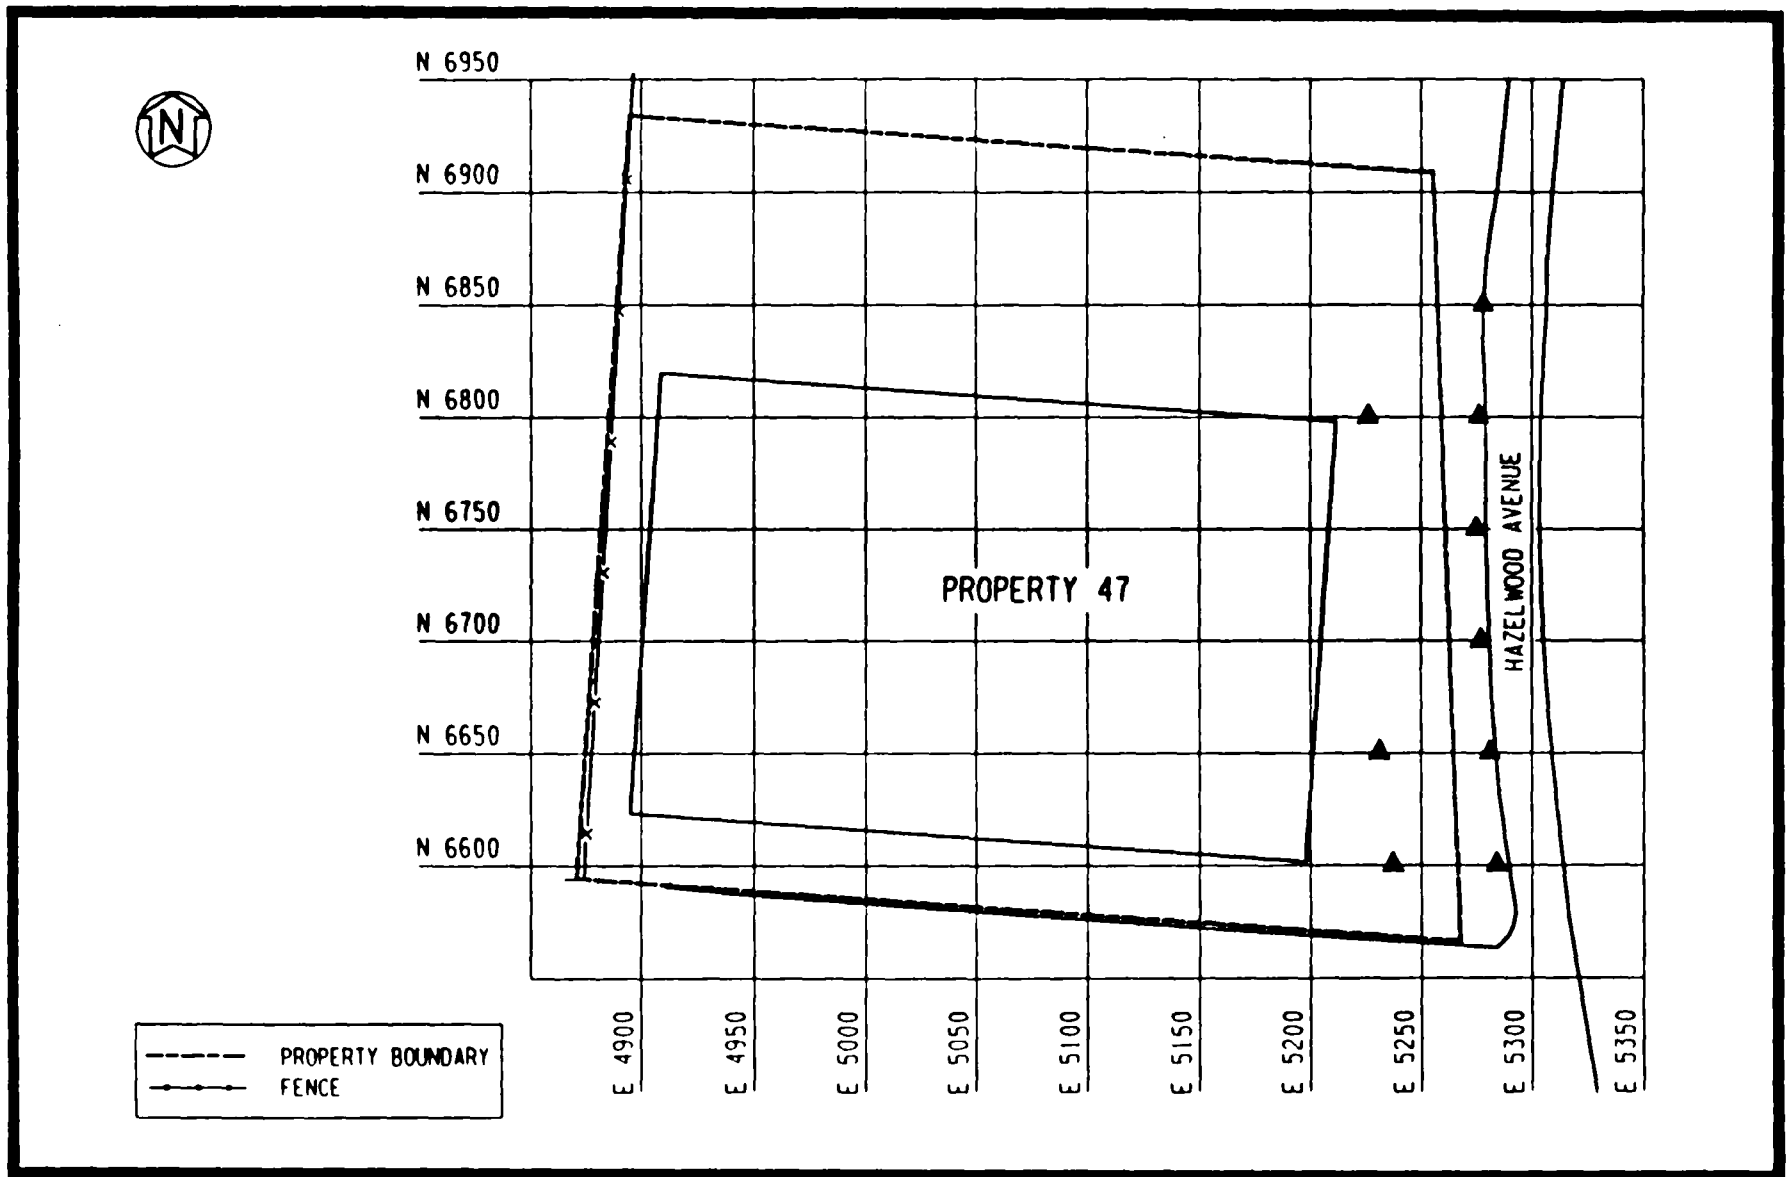
FIGURE 5-100 SOIL SAMPLING LOCATIONS FOR RADIOLOGICAL CHARACTERIZATION OF HAUL ROADS VICINITY PROPERTY 47

Property 47 is located on Hazelwood Avenue. Locations from which soil samples were collected and analyzed are shown in Figure 5-100. Analytical results for soil (Table 5-63) revealed three areas with elevated concentrations of thorium-230, which ranged from 0.9 to 110 pCi/g. Areas and depths of radioactive contamination at Property 47 are shown in Figure 5-101.

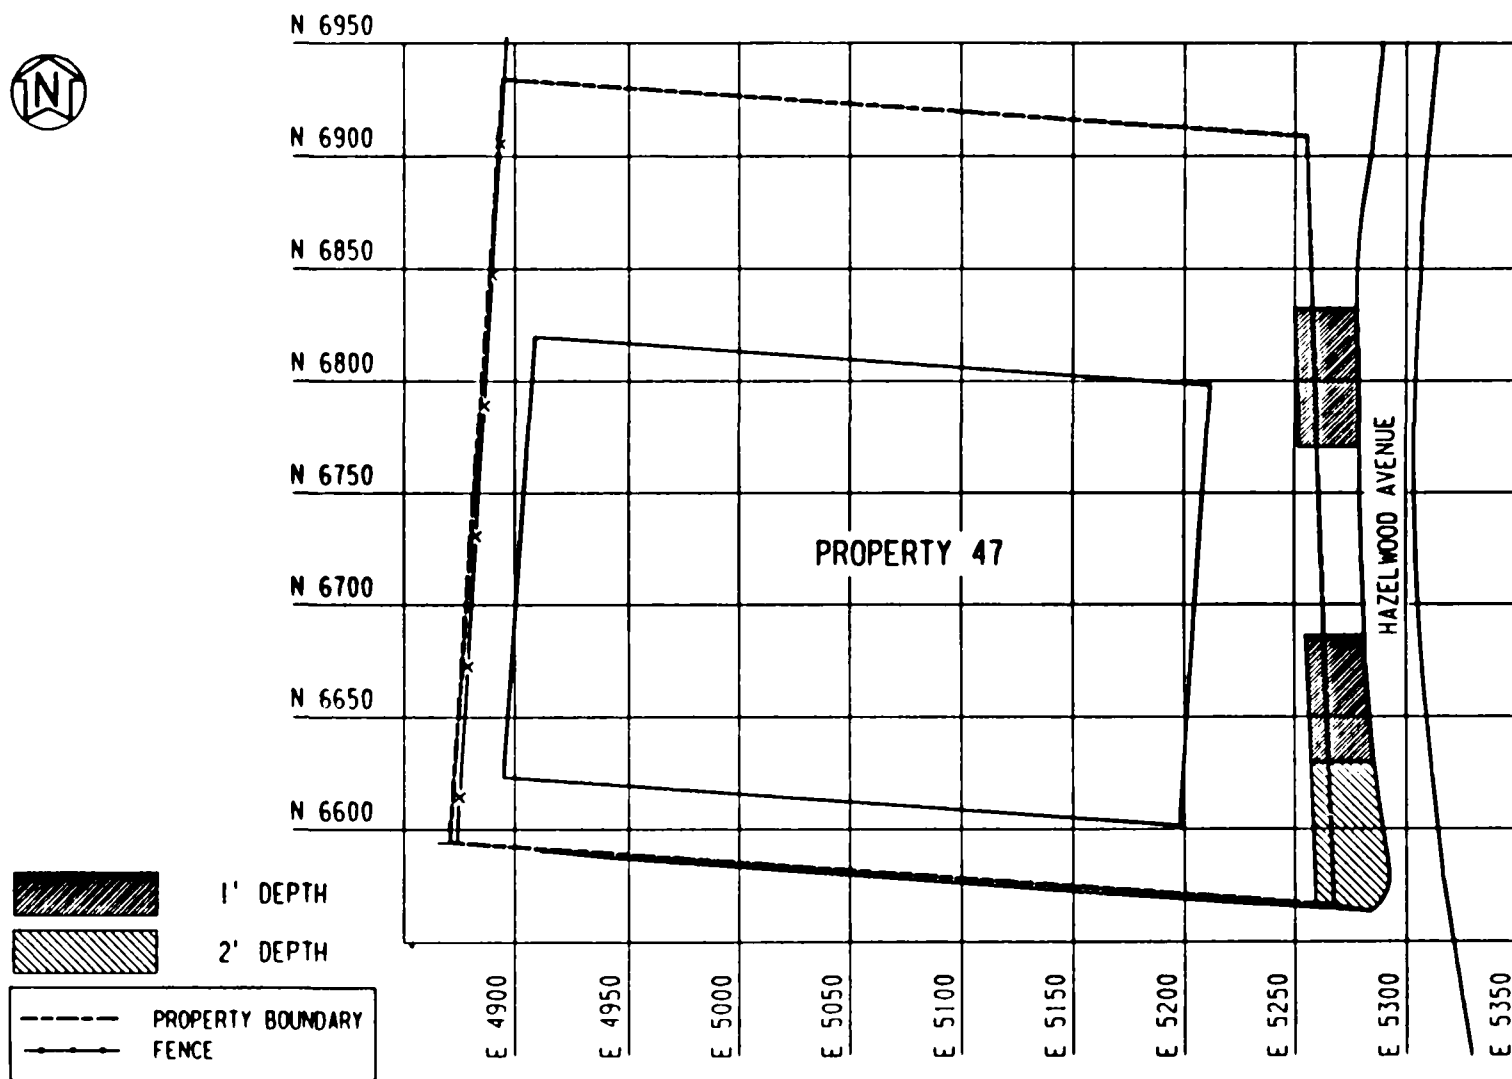
FIGURE 5-101 AREAS AND DEPTHS OF RADIOACTIVE CONTAMINATION
AT HAUL ROADS VICINITY PROPERTY 47

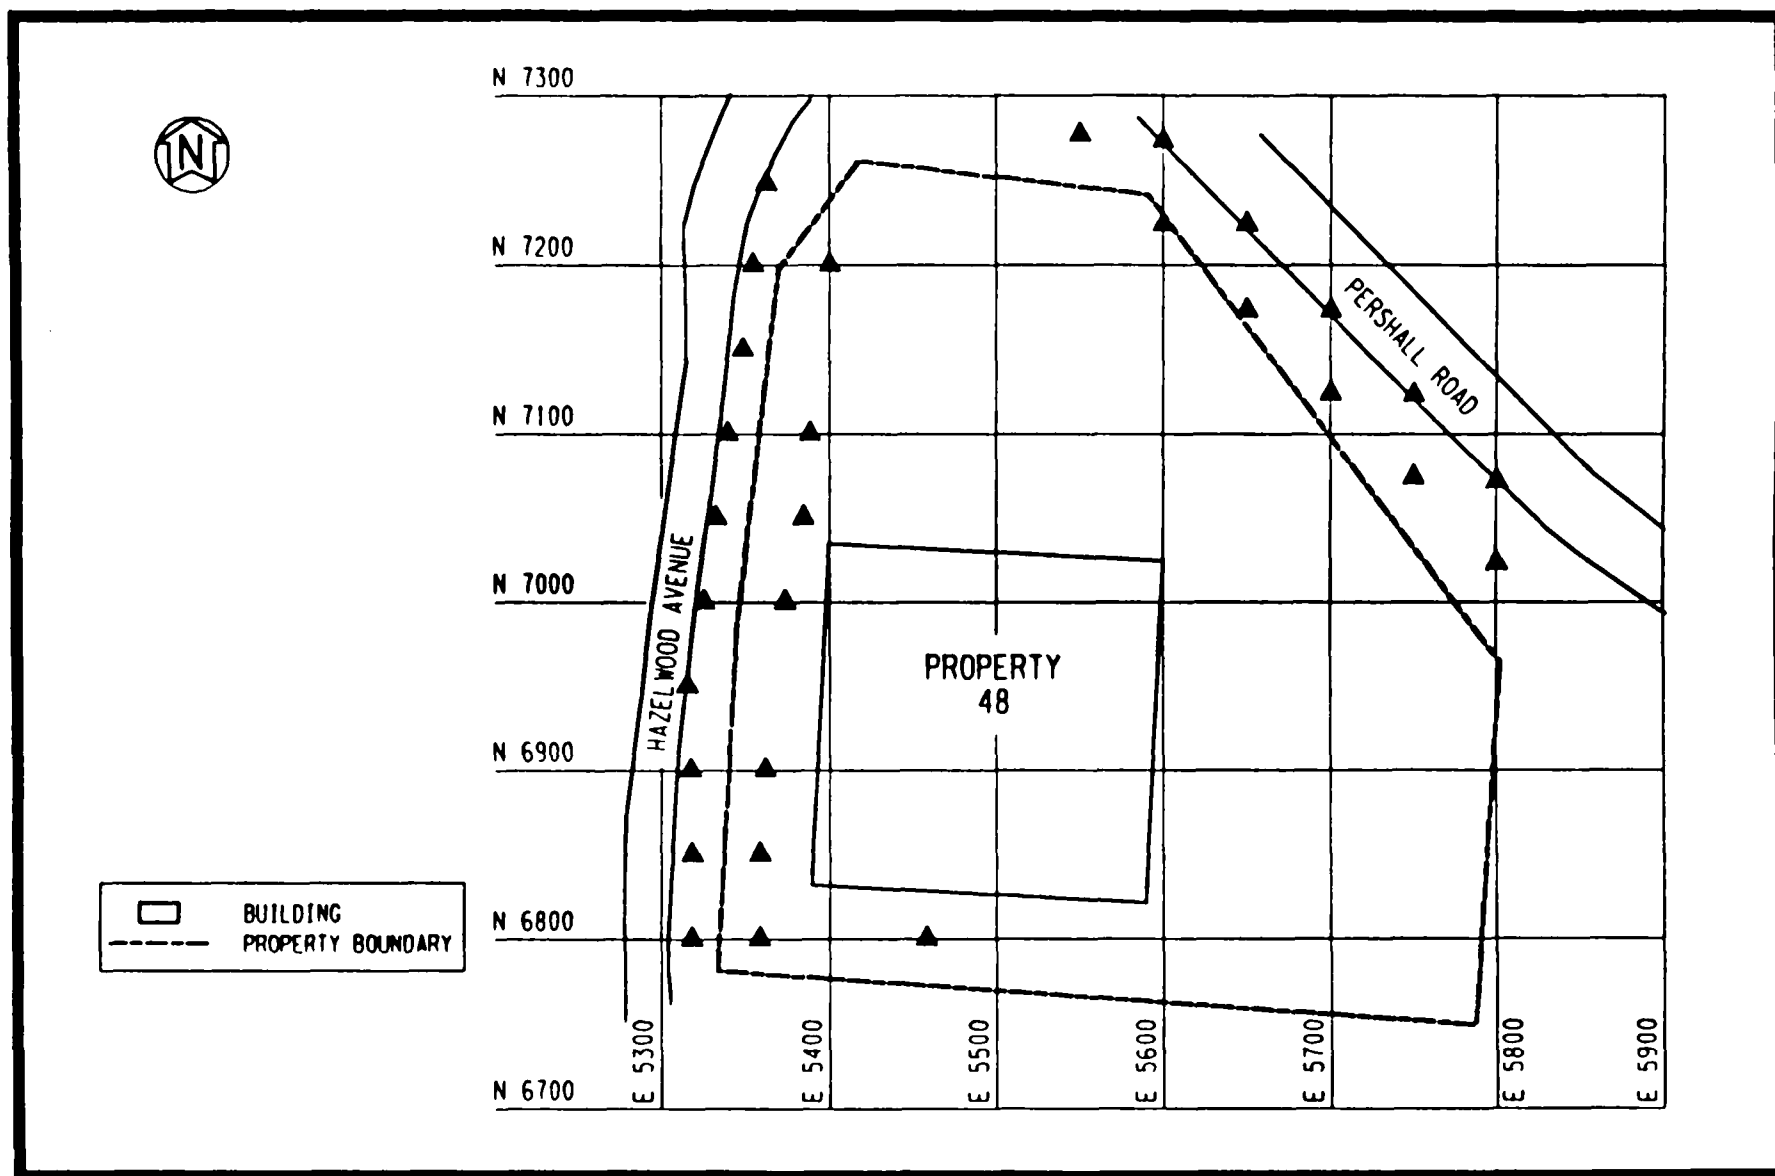
FIGURE 5-102 SOIL SAMPLING LOCATIONS FOR RADIOLOGICAL CHARACTERIZATION OF HAUL ROADS VICINITY PROPERTY 48

Property 48 is bordered by Hazelwood Avenue on the west and Pershall Road on the east. Locations from which soil samples were collected and analyzed are shown in Figure 5-102. Analytical results for soil (Table 5-64) revealed eight sampling locations exhibiting elevated concentrations of thorium-230, which ranged from 0.7 to 34 pCi/g. Areas and depths of radioactive contamination at Property 48 are shown in Figure 5-103.

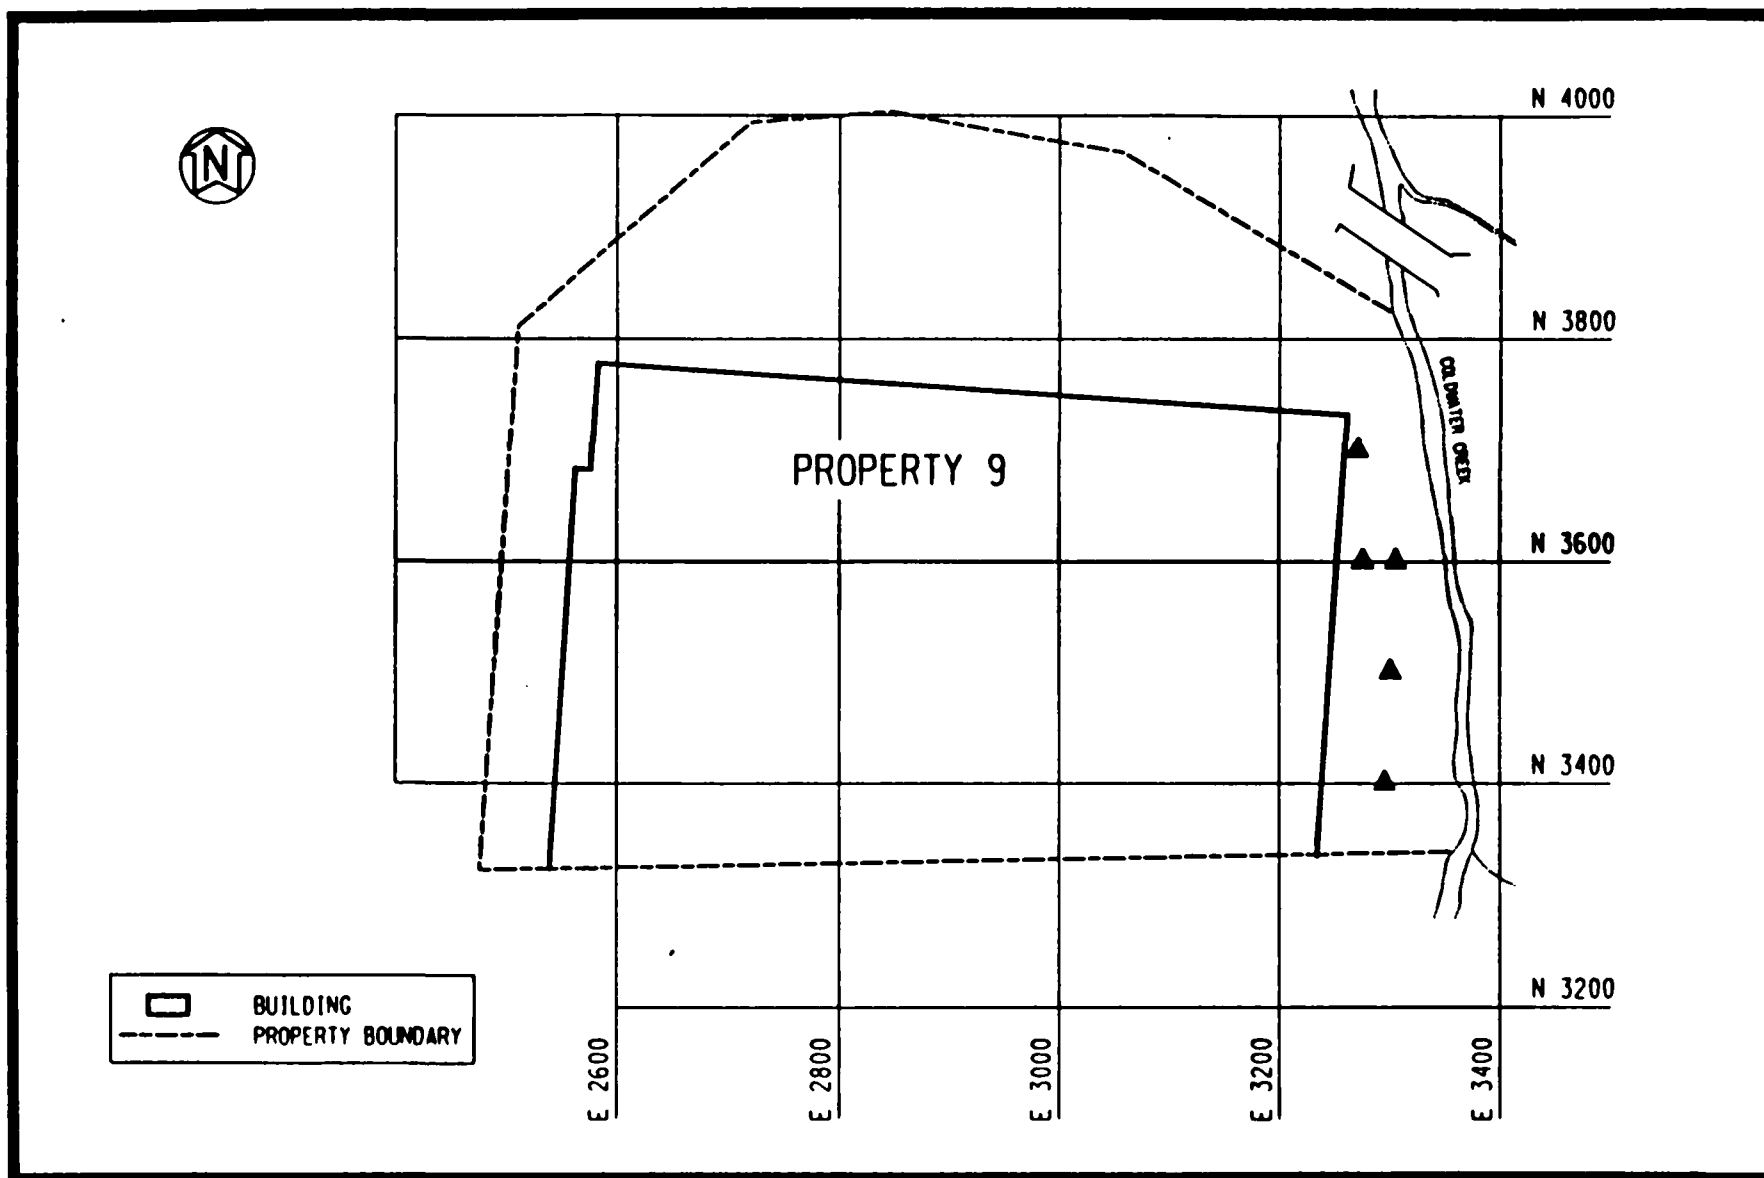
FIGURE 6-13 SOIL SAMPLING LOCATION FOR RADIOLOGICAL CHARACTERIZATION OF PROPERTY 9 ON COLDWATER CREEK

The soil sampling locations on Property 9 are shown in Figure 6-13. Analytical results for soil (Table 6-21) revealed an elevated concentration of thorium-230 in one area sampled. Uranium-238 concentrations were below 10 pCi/g. Radium-226 concentrations ranged from less than 0.5 to 2.3 pCi/g. Concentrations of thorium-232 and thorium-230 for Property 9 ranged from less than 1 to 3 and 1 to 6.5 pCi/g, respectively.

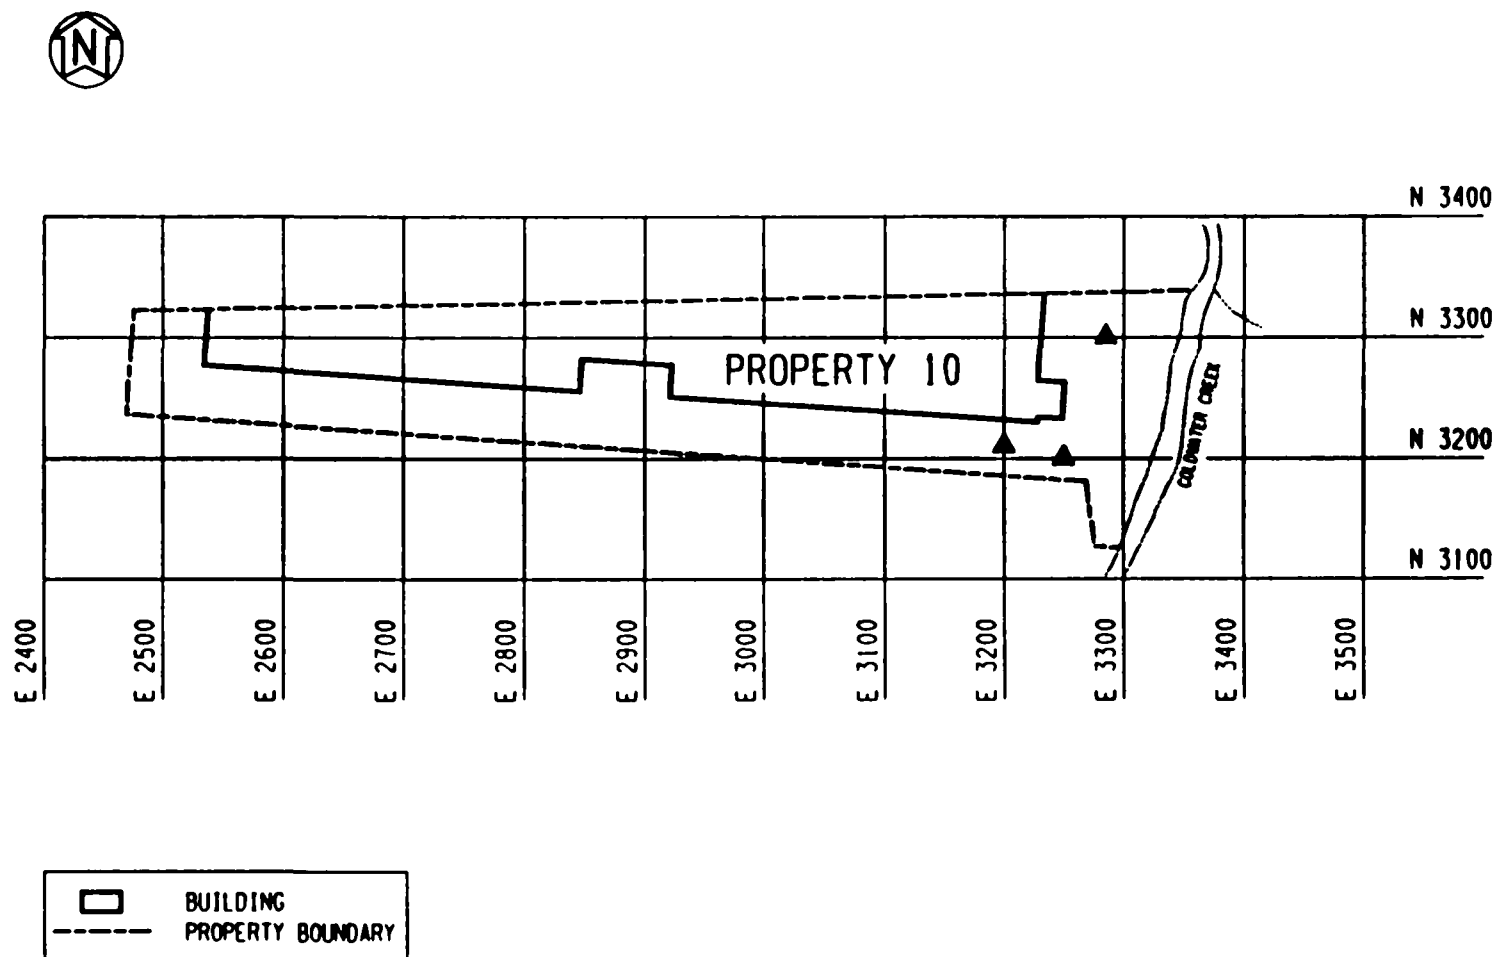
FIGURE 6-14 SOIL SAMPLING LOCATION FOR RADIOLOGICAL CHARACTERIZATION OF PROPERTY 10 ON COLDWATER CREEK

The soil sampling locations on Property 10 are shown in Figure 6-14. Analytical results for soil (Table 6-23) revealed no elevated levels of the radionuclides above DOE guidelines. Uranium-238 concentrations were less than 11 pCi/g. Radium-226 concentrations ranged from 1.6 to 1.8 pCi/g. Concentrations of thorium-232 and thorium-230 ranged from 1.7 to 3 and 1.5 to 5.7 pCi/g, respectively.

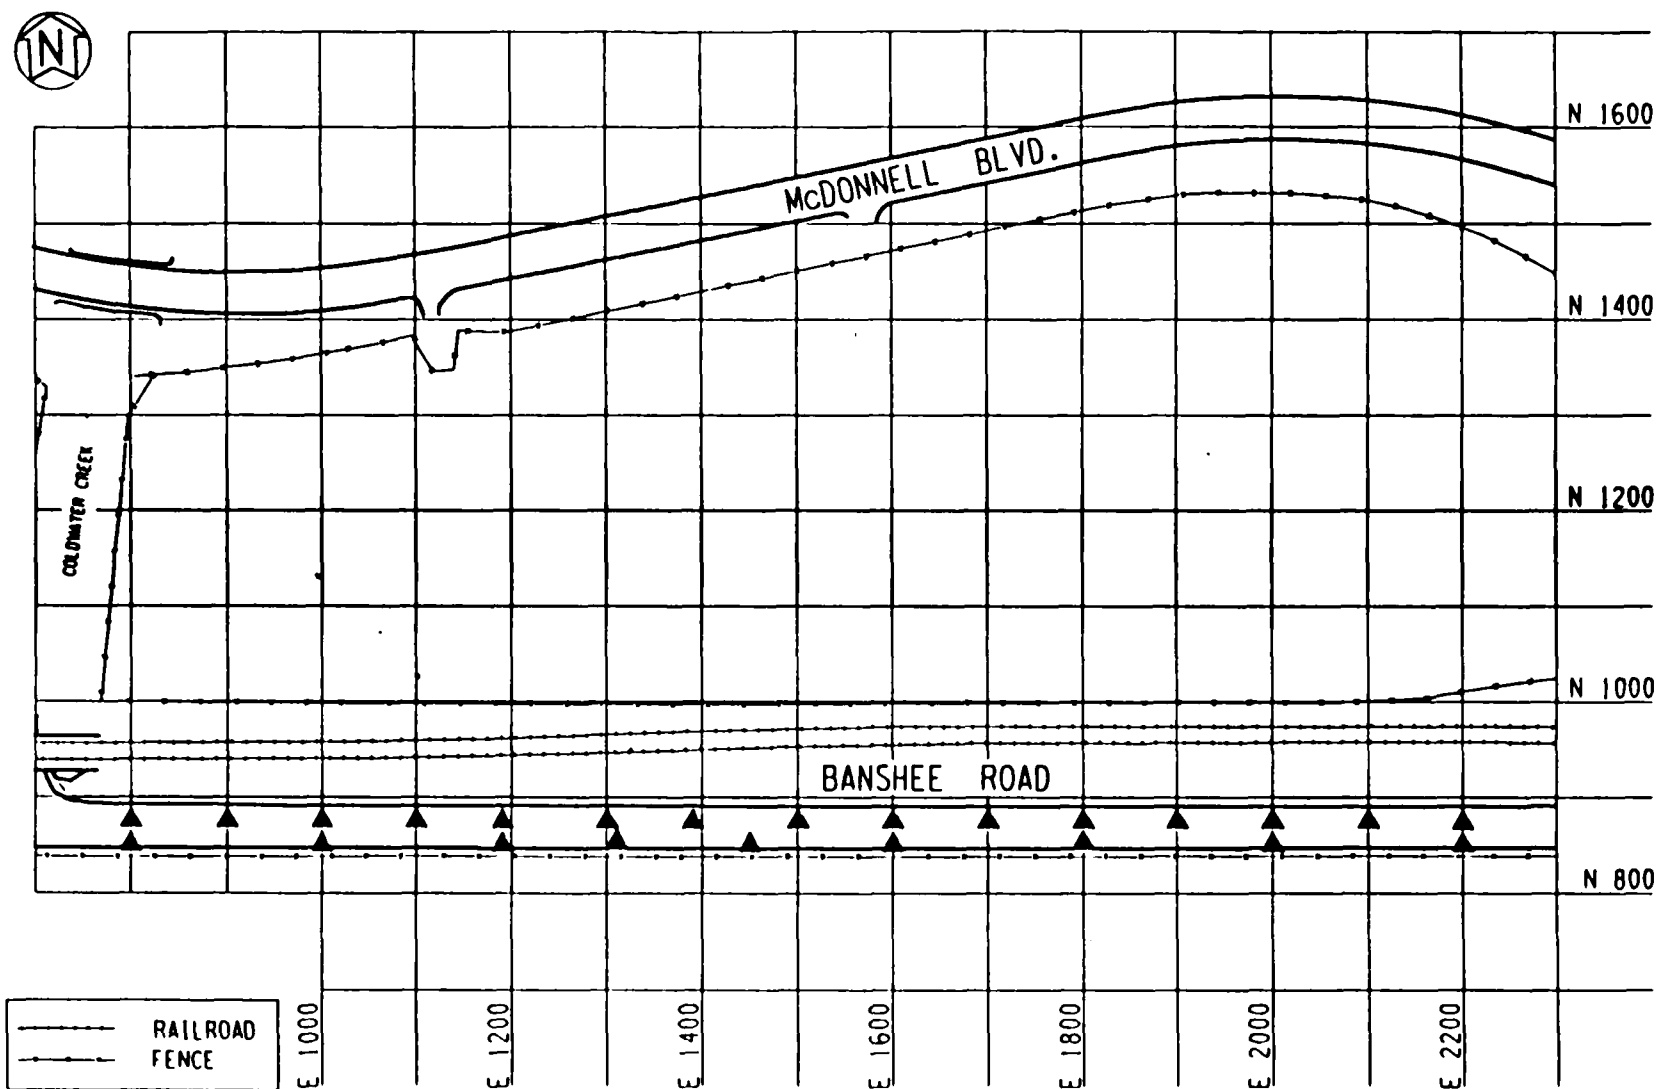
FIGURE 7-1 SURFACE SOIL SAMPLING LOCATIONS FOR RADIOLOGICAL CHARACTERIZATION OF BANSHEE ROAD

Surface soil sampling locations at Banshee Road are shown in Figure 7-1. A surface soil sample was taken below the asphalt at each location. Subsurface soil sampling locations are shown in Figure 7-2. Analytical results for soil (Table 7-2) revealed two areas with elevated concentrations of thorium-230 in surface soils. Concentrations of uranium-238 at Banshee Road were less than 46 pCi/g. Radium-226 and thorium-232 concentrations were less than 7.1 pCi/g. Concentrations of thorium-230 ranged from less than 0.4

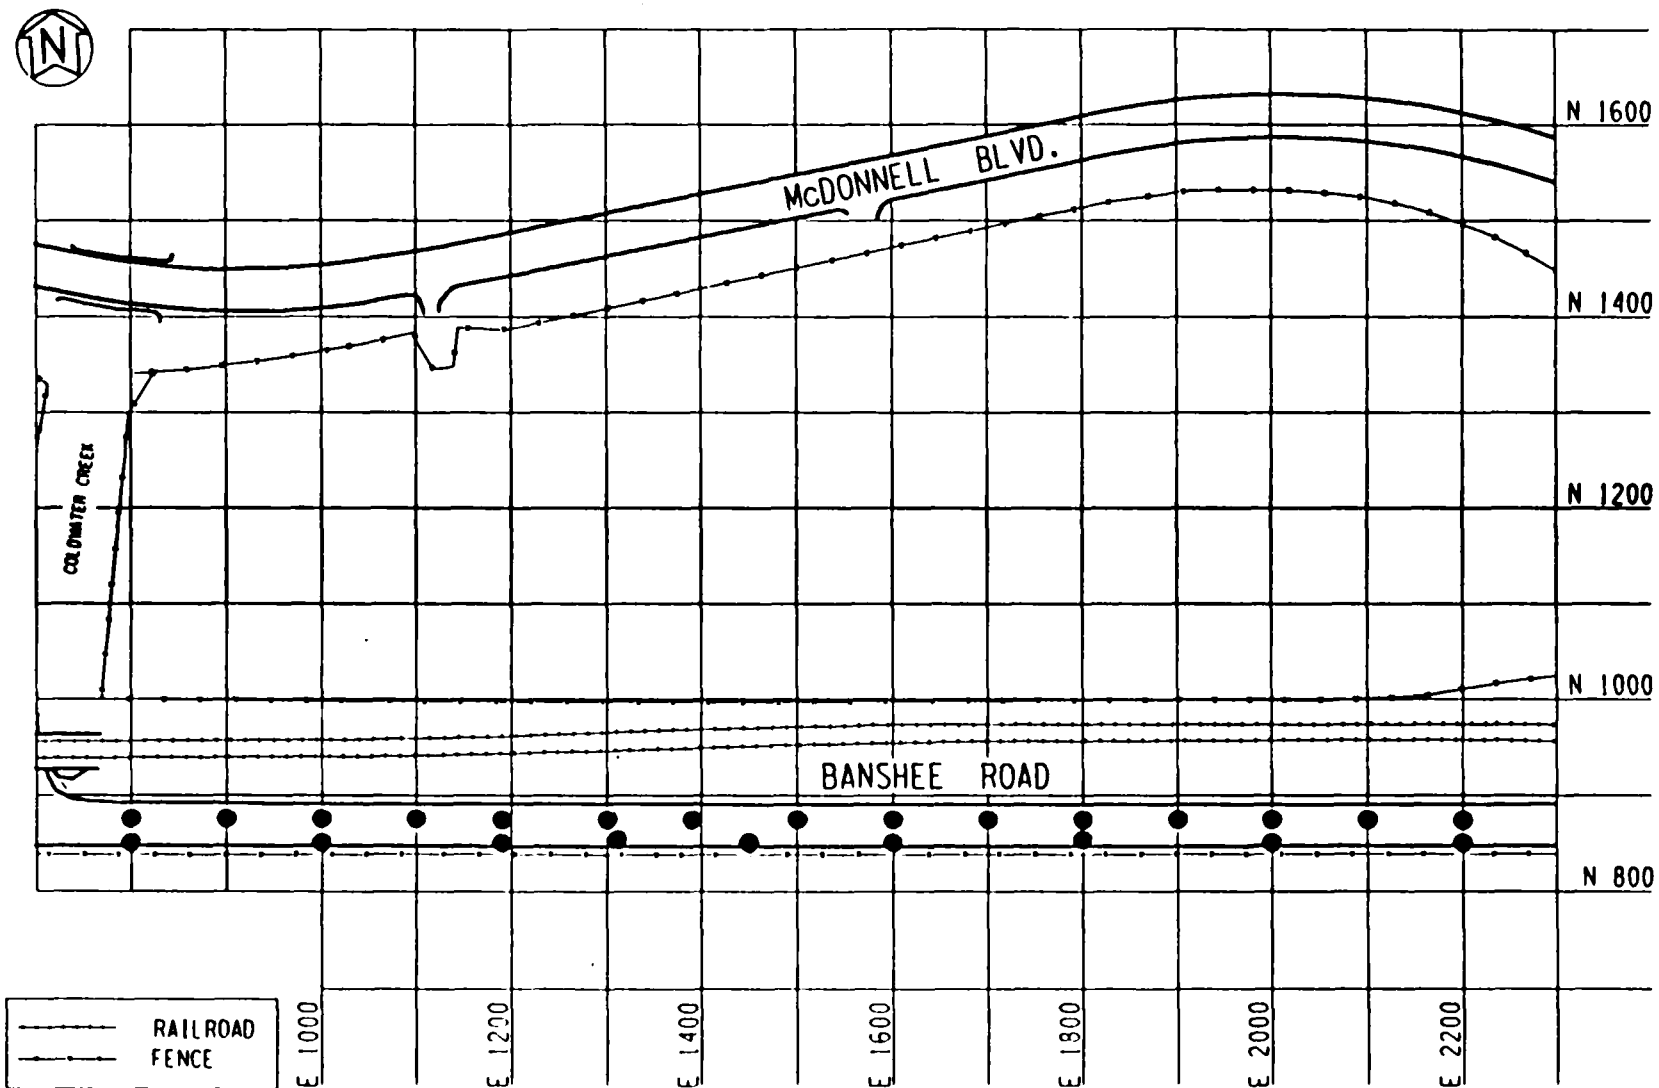
FIGURE 7-2 SUBSURFACE SOIL SAMPLING LOCATIONS FOR RADIOLOGICAL CHARACTERIZATION OF BANSHEE ROAD

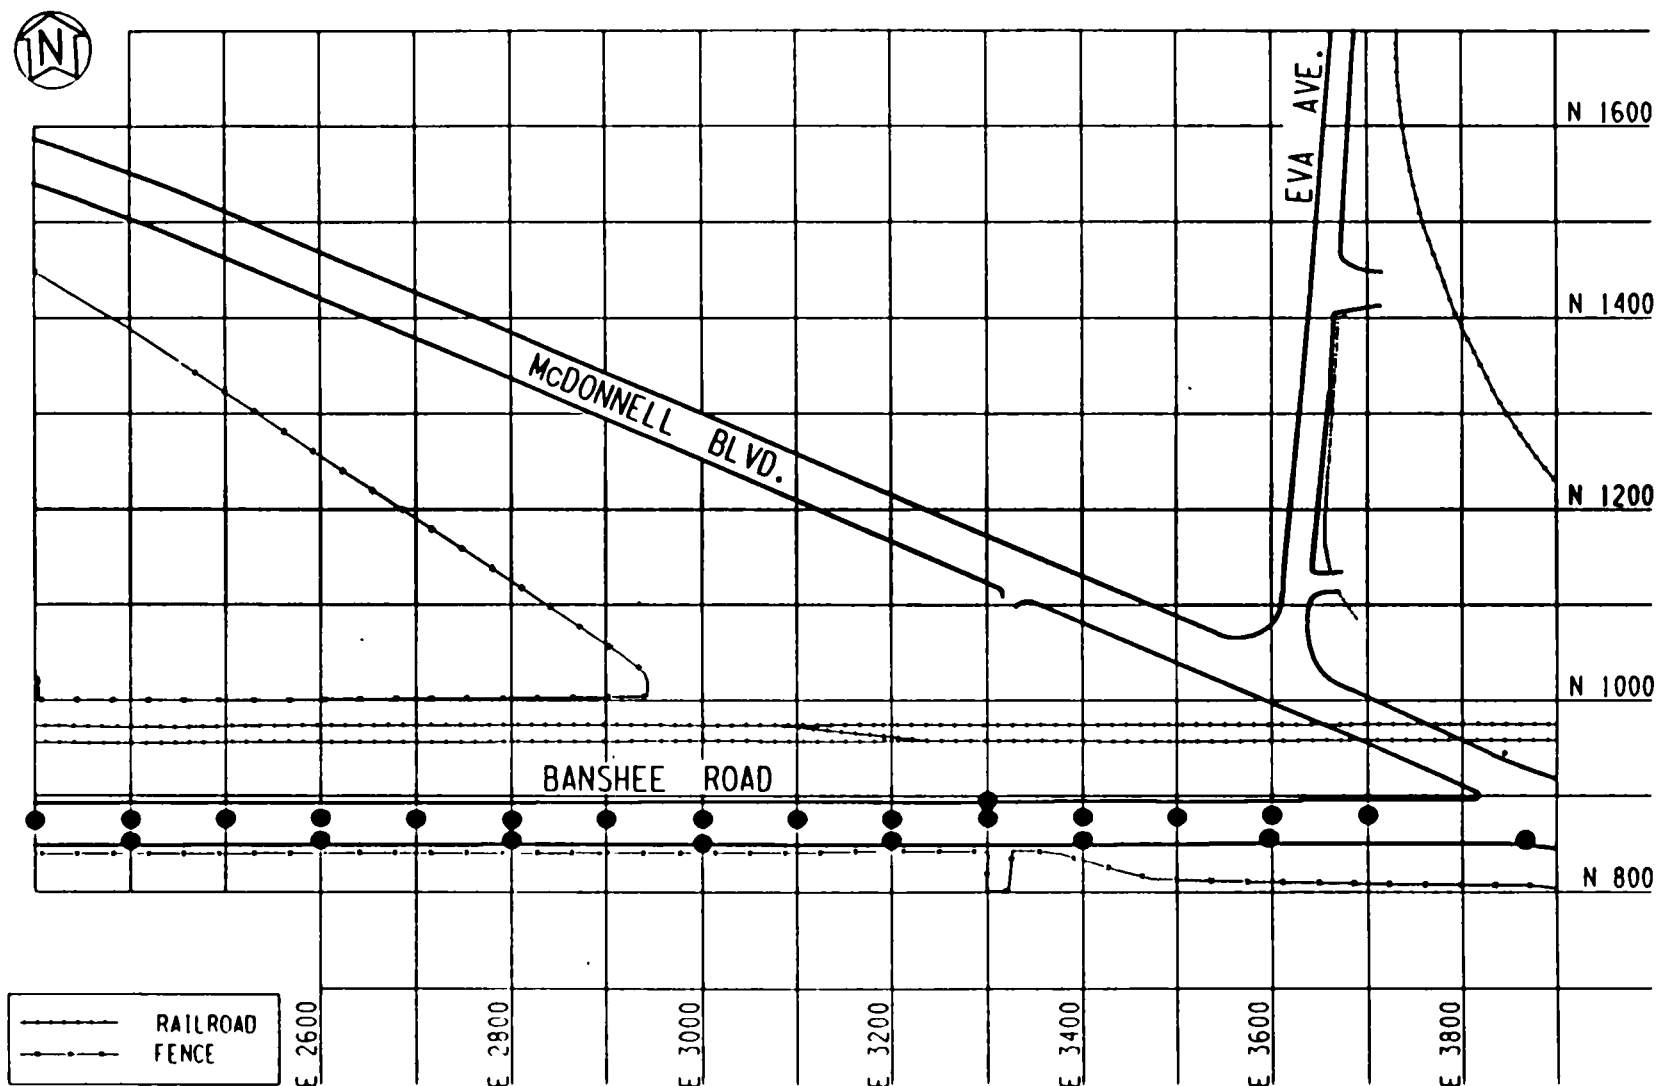
FIGURE 7-2 SUBSURFACE SOIL SAMPLING LOCATIONS FOR RADIOLOGICAL CHARACTERIZATION OF BANSHEE ROAD (CONT.)

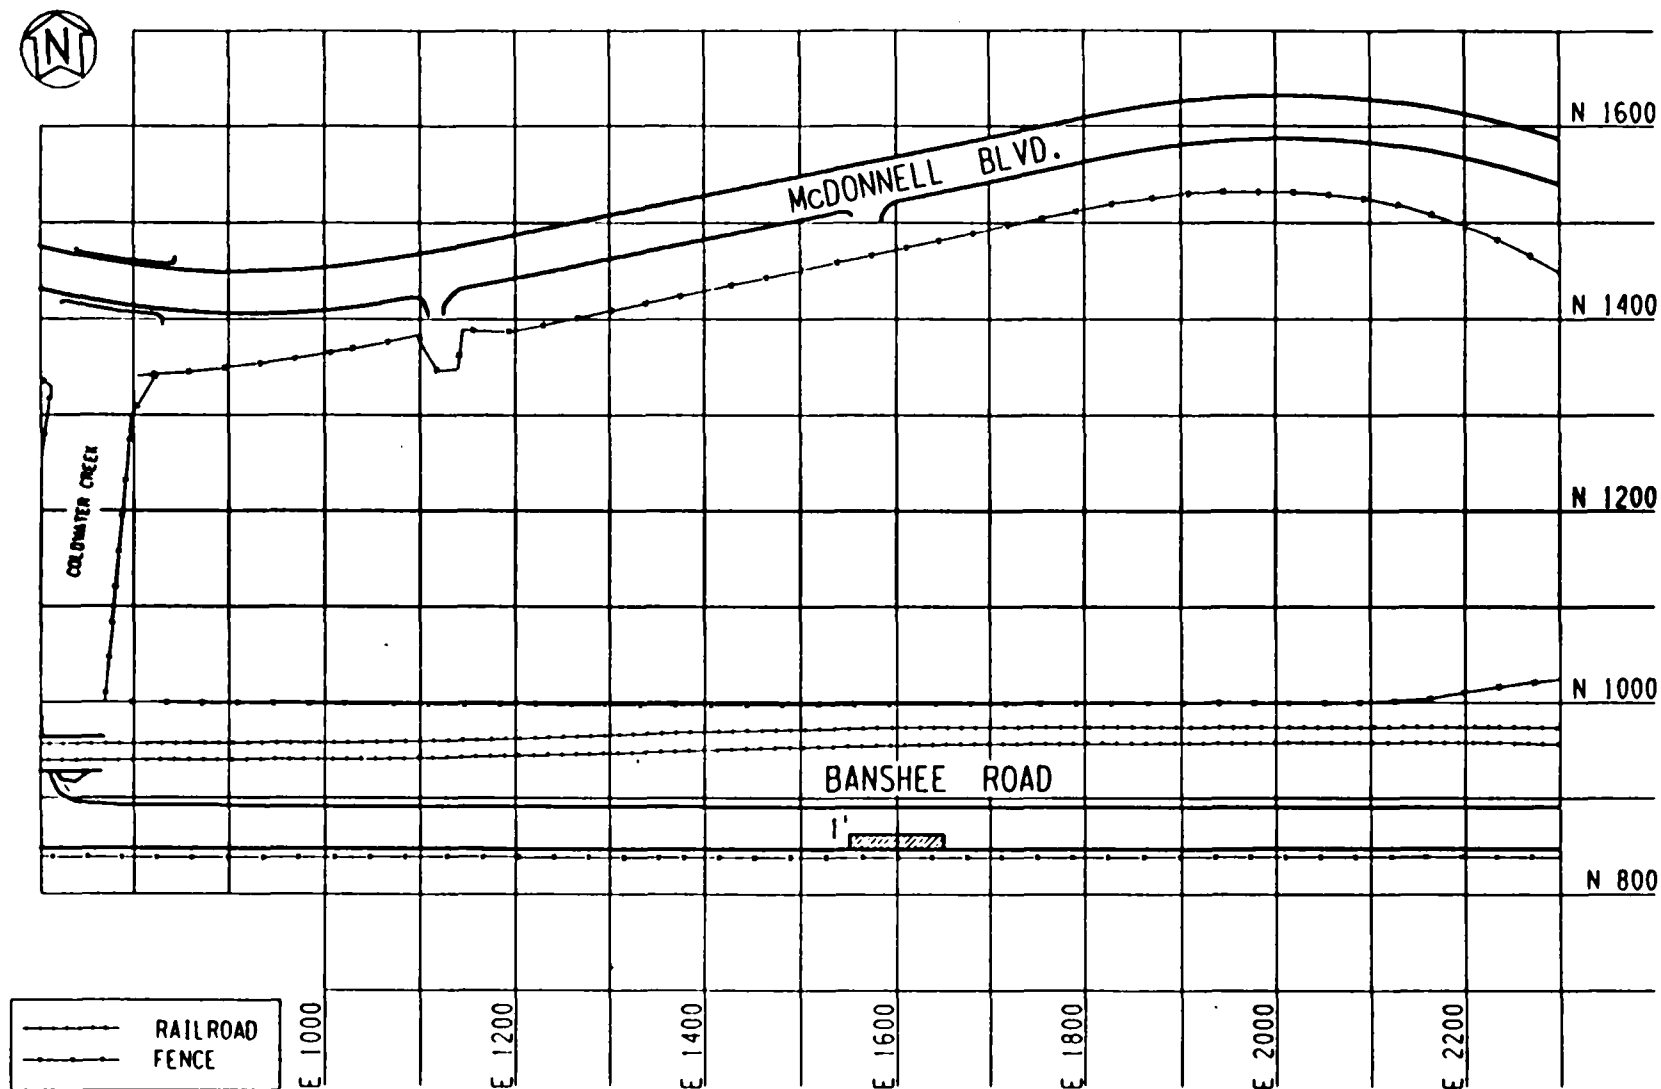
FIGURE 7-3 AREAS AND DEPTHS OF RADIOACTIVE CONTAMINATION AT BANSHEE ROAD

to 34 pCi/g. Areas and depths of radioactive contamination at Banshee Road are shown in Figure 7-3.

Radioactive contamination (exceeding DOE guidelines) is present at two locations on Banshee Road, extending to a depth of 0.3 m (1 ft). Essentially all the ditch area north and south of SLAPS is contaminated ranging in depth from 0 to 4.3 m (0 to 14 ft). The 4.3-m (14-ft) depth of contamination occurred at one location. Radioactive contamination is present on the St. Louis Airport Authority property south of SLAPS, extending to a depth of 1.2 m (4 ft) at two locations. In general, the contamination is shallow [0.6 m (2 ft)] and extends the length of SLAPS between SLAPS and Banshee Road. There are several areas south of Banshee Road, on the airport property, that exhibited radioactive contamination in excess of DOE guidelines. These areas are shallow [0 to 0.6 m (0 to 2 ft)] and are confined to the area adjacent to Banshee Road. With the exception of the baseball infields, the ball field area does have radiological contamination to an average depth of 0.3 m (1 ft). Thorium-230 was identified as the primary contaminant on all these properties.
